4. TITLE *(and Subtitle)*	5. TYPE OF REPORT & PERIOD COVERED
THE VAIONT SLIDE, A GEOTECHNICAL ANALYSIS BASED ON NEW GEOLOGIC OBSERVATIONS OF THE FAILURE SURFACE; Volume I: MAIN TEXT	Final report
	6. PERFORMING ORG. REPORT NUMBER

7. AUTHOR(s)	8. CONTRACT OR GRANT NUMBER(s)
A. J. Hendron, Jr. F. D. Patton	Contract No. DACW39-79-C-0063

11. CONTROLLING OFFICE NAME AND ADDRESS	12. REPORT DATE
DEPARTMENT OF THE ARMY US Army Corps of Engineers Washington, DC 20314-1000	June 1985
	13. NUMBER OF PAGES

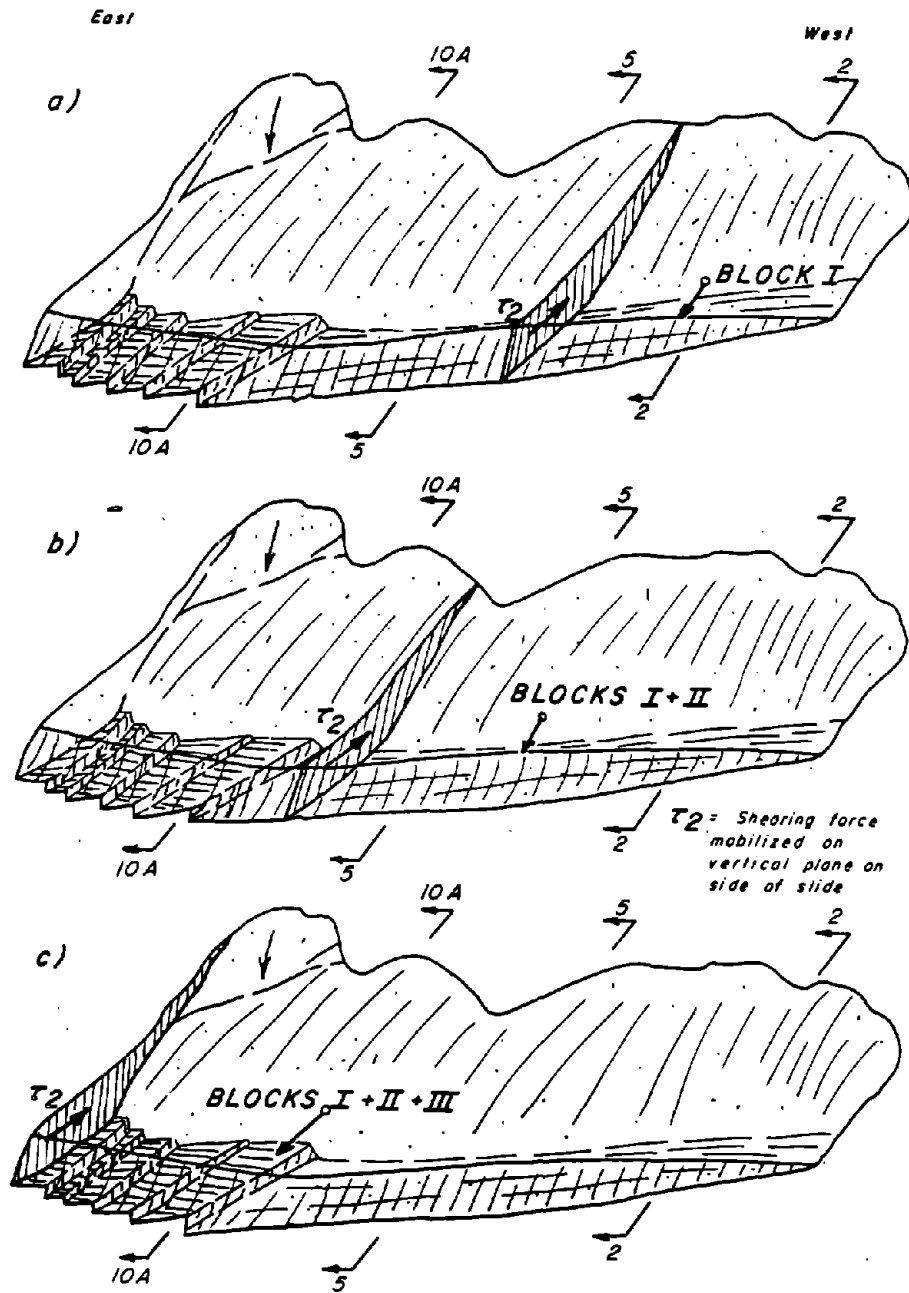
Figure 38.   Vaiont Slide, schematic illustration of the three
             blocks used in the three-dimensional stability
             analysis

The schematic diagram in Figure 38 shows the three-dimensional nature of the blocks selected for the calculation of forces acting in the upstream (easterly) direction. These are designated as Block I, Block I + II, and Block I + II + III. In Appendix D the factor of safety of Block I (Figure 38a) is shown to be 1.07 for $\phi = 12°$, $\beta = 40°$, $\phi_R = 36°$ and high rainfall with reservoir elevation at 710 m. The factor of safety of Block I + II is 1.31 (Figure 38b) and the factor of safety of Block I + II + III is 1.00 (Figure 38c). These three-dimensional analyses, which consider the shear forces between sections caused by the upstream dip of the strata, account for the fact that the entire slide came down at one time. This was not apparent from the two-dimensional analyses which yielded calculated factors of safety for Sections 2, 5, and 10A which were quite different for each section. The three-dimensional calculations also account for the fact that if the strength on the bedding planes was as low as 12°, the slide mass could have been stable, but not greatly above a factor of safety of 1.0, before the reservoir was built. However, this condition required a large resistance along the eastern boundary of the slide. The epicenters of small tremors reported near the eastern boundary of the slide during the history of movement agree with the conclusion that a significant resistance was developed at this boundary.

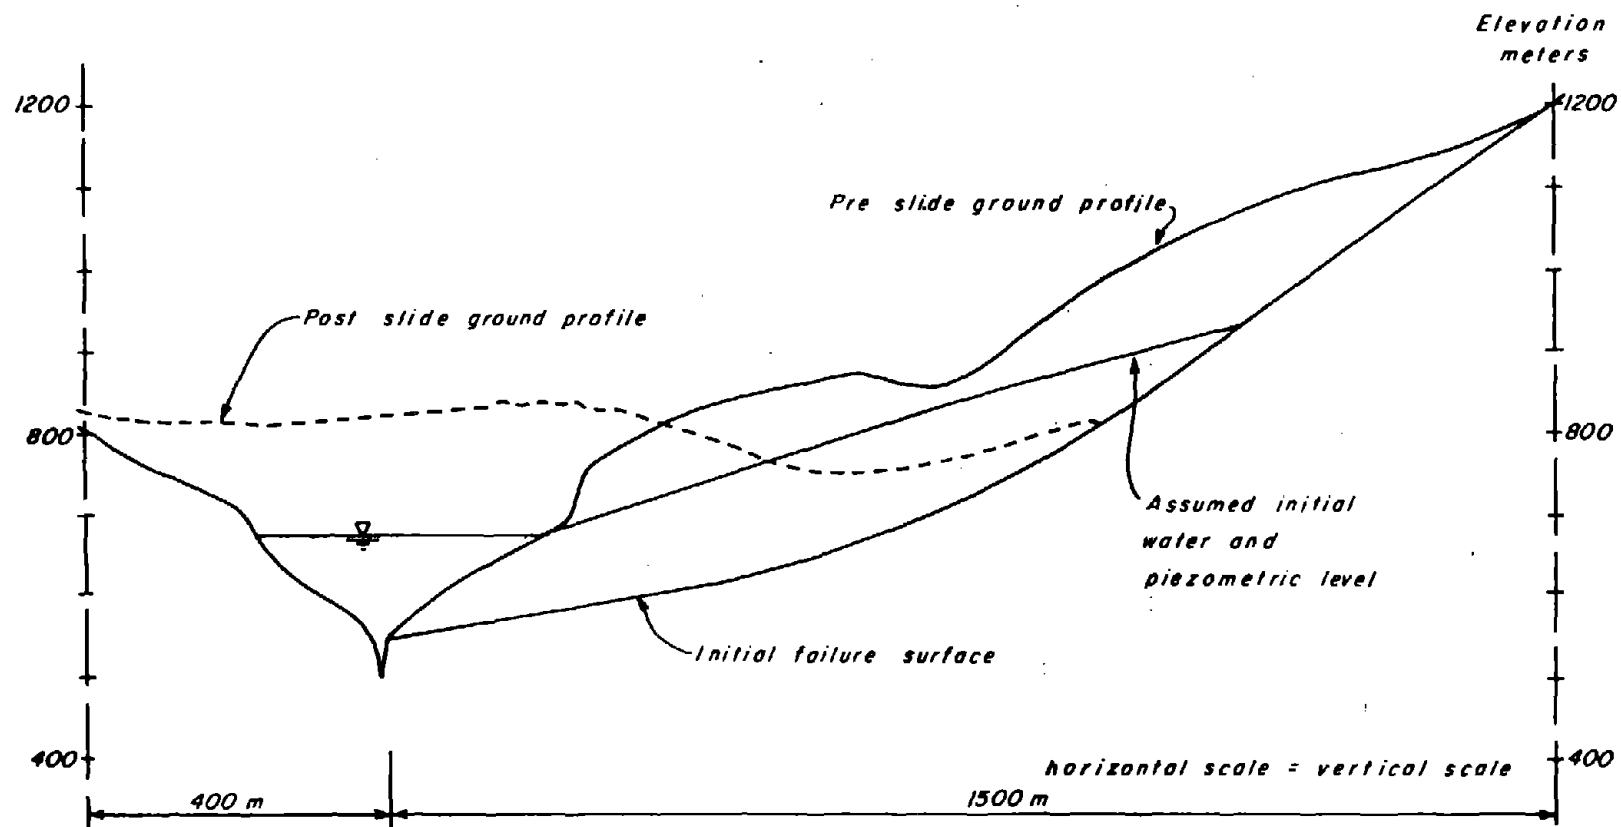
Figure 39. Vaiont Slide showing pre- and post-slide ground profiles,
assumed failure surface, water and piezometric levels

After a review of the pre- and postslide ground profiles reported
by Selli et al. (1964), Anderson selected the section shown in Figure 39
for analysis. The water and piezometric levels were assumed to be the
same as shown. It was also assumed that the water and piezometric
levels remained at the same position in the slide mass as the mass moved
down the slope, except in the toe region which is discussed below.

Comparing the pre- and postslide profiles in Figure 39, it appears that the toe of the slide moved laterally about 400 m while the upper portion moved farther. Although this movement is larger than reported by Müller (1964a) on the basis of identification of specific surface features, it is in reasonable agreement with the postslide ground profile and will provide a conservative estimate of the loss of strength and maximum velocity.

From Figure 39 it is apparent that immediately after the beginning of movement the toe of the slide would begin to displace, and perhaps ride over, the water in the reservoir. The pore pressure at the slide surface in the toe region (the toe region is defined to be that part of the slide that has progressed beyond the original toe position) is very difficult to estimate and so two bounding conditions have been assumed. What has been defined as the "dry toe" condition assumes that the pore pressure in the toe region is zero. The "wet toe" condition, which is envisaged as a hydroplaning of the toe, assumes pore pressures in the toe region sufficient to reduce the effective stress and the resulting frictional strength to zero.

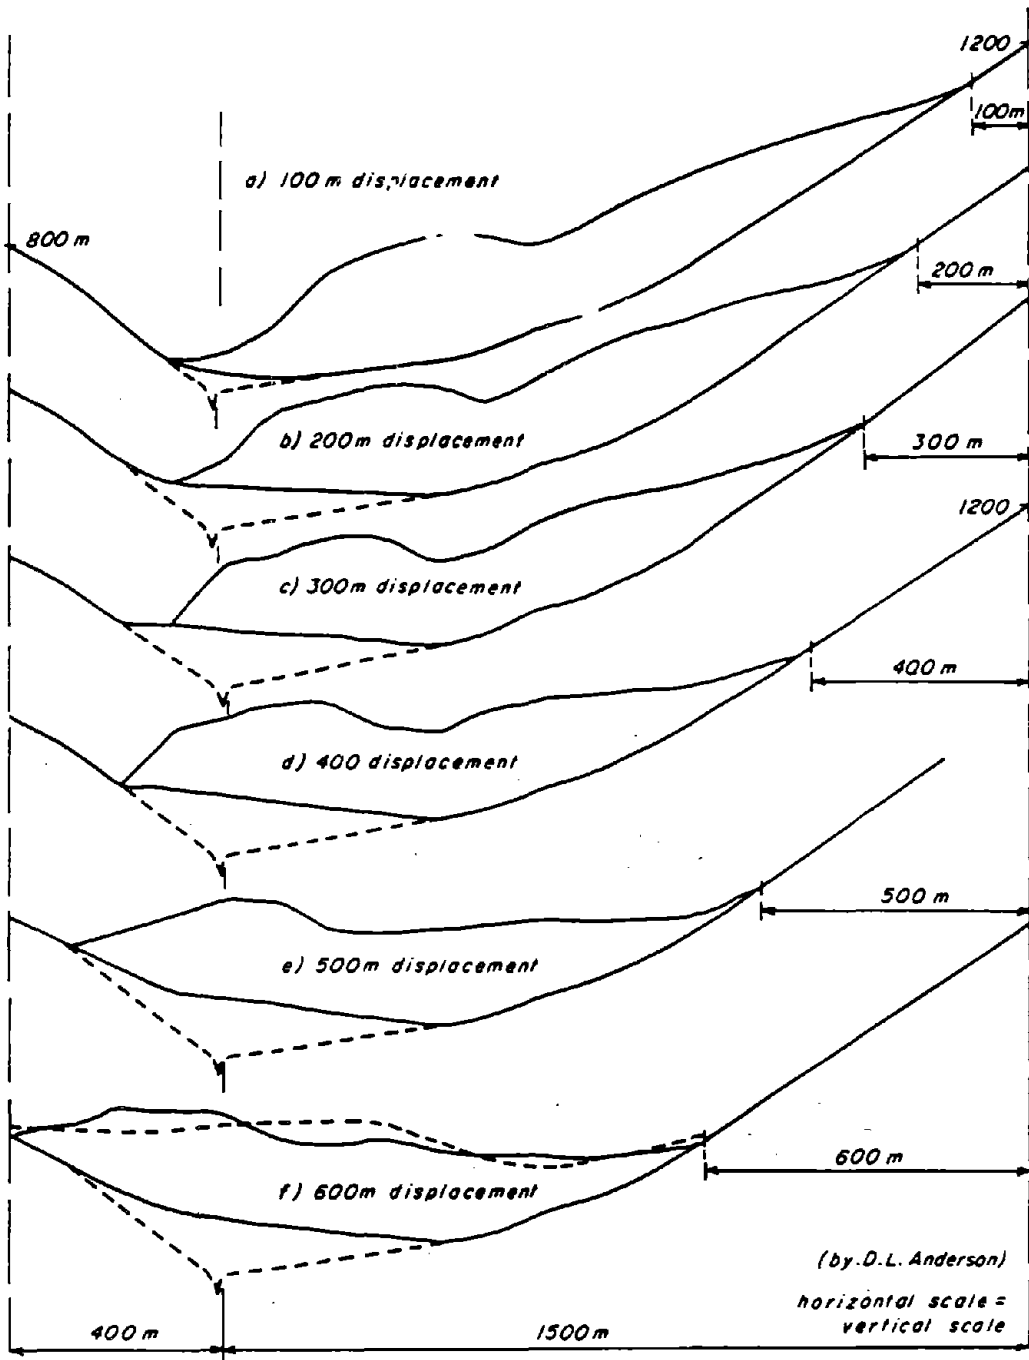
Figure 40. Vaiont Slide, assumed geometry as slide movement progresses

Figure 40 illustrates the configuration of the slide at various stages. At each stage the static analysis was used to determine the acceleration and velocity as described in Appendix E.

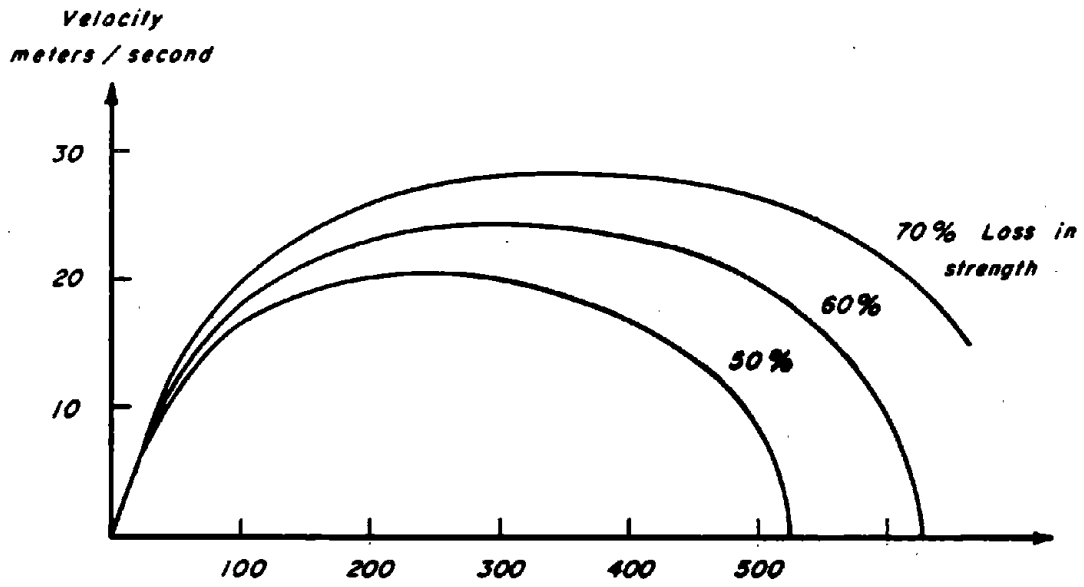
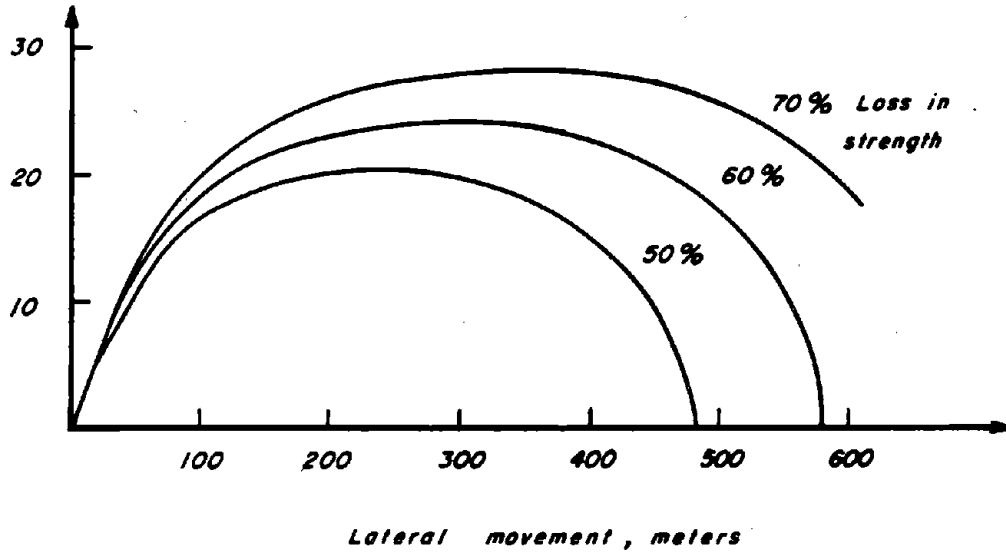
Figure 41. Vaiont Slide, velocity profiles

The dynamic calculations were carried out for the two boundary toe conditions and the results are shown in Figure 41. It shows plots of slide velocity and reservoir slide displacement for different values of percentage strength loss along the failure surfaces. The loss in strength is defined as the change in strength from that strength required for an initial static factor of safety of 1.0. If cohesion is neglected, and if ϕ is the friction angle for a factor of safety of 1.0, then a 60 percent loss in strength could be achieved by taking tan $\phi_d = 0.4$ tan ϕ_{cr}, where ϕ_d is the dynamic angle of shearing resistance and ϕ_{cr} is the static angle of shearing resistance for a factor of

It is apparent from the results shown in Figure 41 that the toe
friction condition is not an important parameter for this slide. It
would then appear for the case analyzed that if the slide moved later-
ally about 500 m, it must have suffered a loss in strength of about 50
percent. The maximum slide velocity consistent with this loss in
strength would be about 20 m/sec.

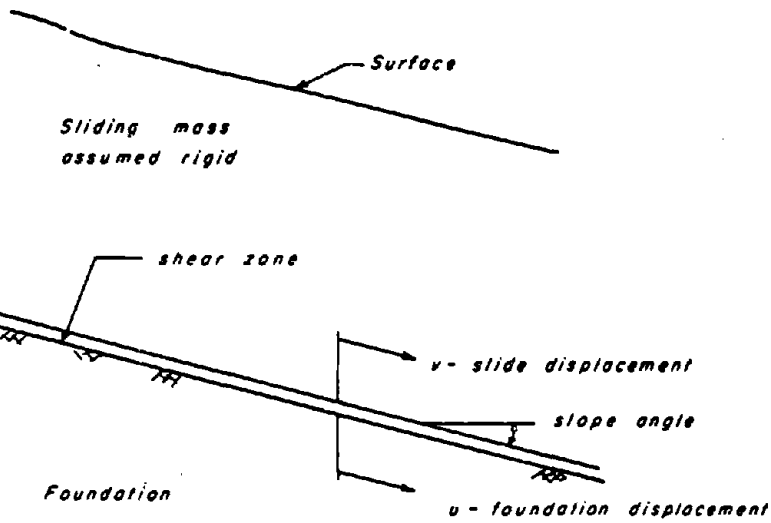
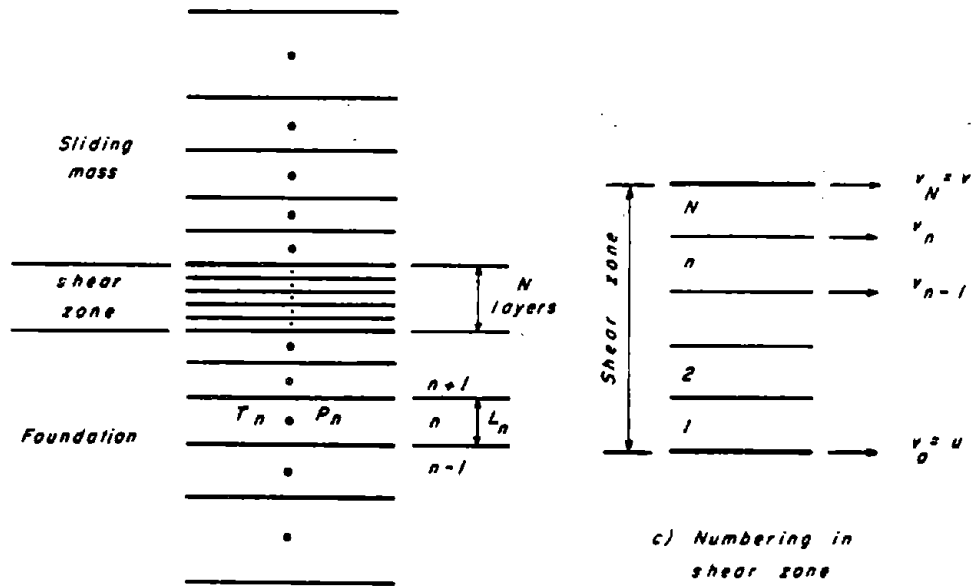
Figure 42. Assumptions used in calculations of slide induced fluid pressures

The sliding mass is assumed to move as a rigid body with all the deformation taking place in a small or narrow shear zone as shown in Figure 42a. For purposes of calculation, the foundation, shear zone, and the sliding mass are divided up into a number of thinner layers as shown in Figure 42b.

The displacement of the slide is denoted as v. For the shear zone the displacements are given by v_n which represents the displacement at the top of the n^{th} layer as shown in Figure 42c. T_n and p_n represent the temperature and pressure, respectively, at the center of the n^{th} layer.

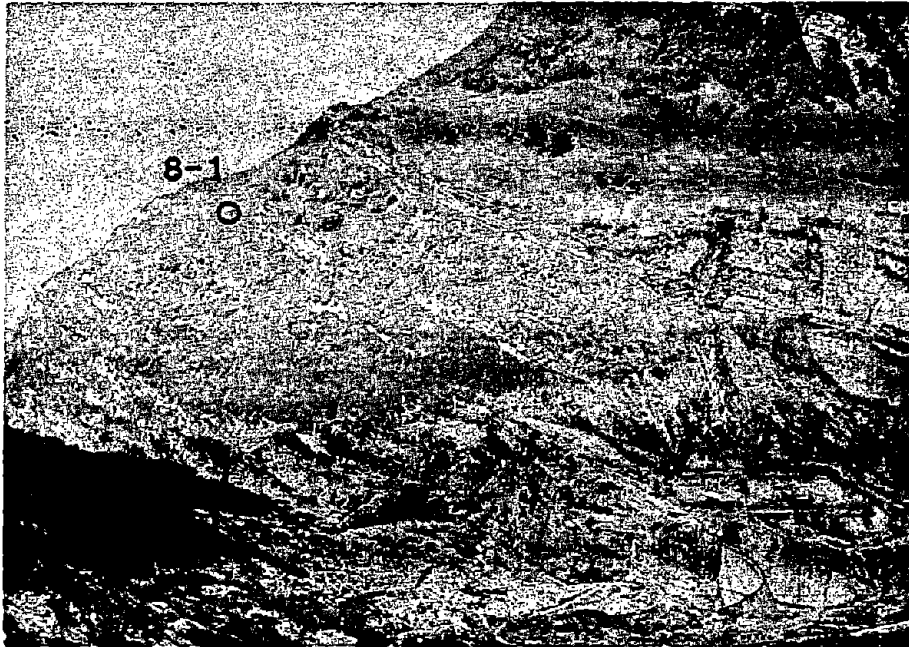
Photo 1.   Location 8-1 with respect to the Vaiont Dam   (also shown on
           Figures 11 and 12);   photo was taken from western part of
           surface of sliding near location 522-5B

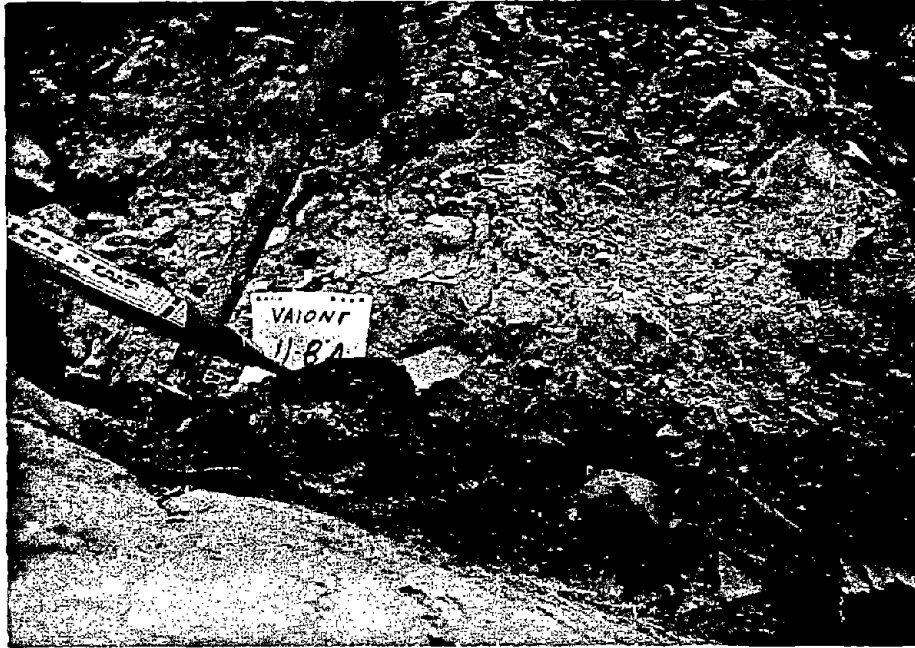
Photo 13. Location 11-8A (20 m above location 11-7B); clay layer along failure surface is 0.5 to 2 cm thick with a dip of 22° N

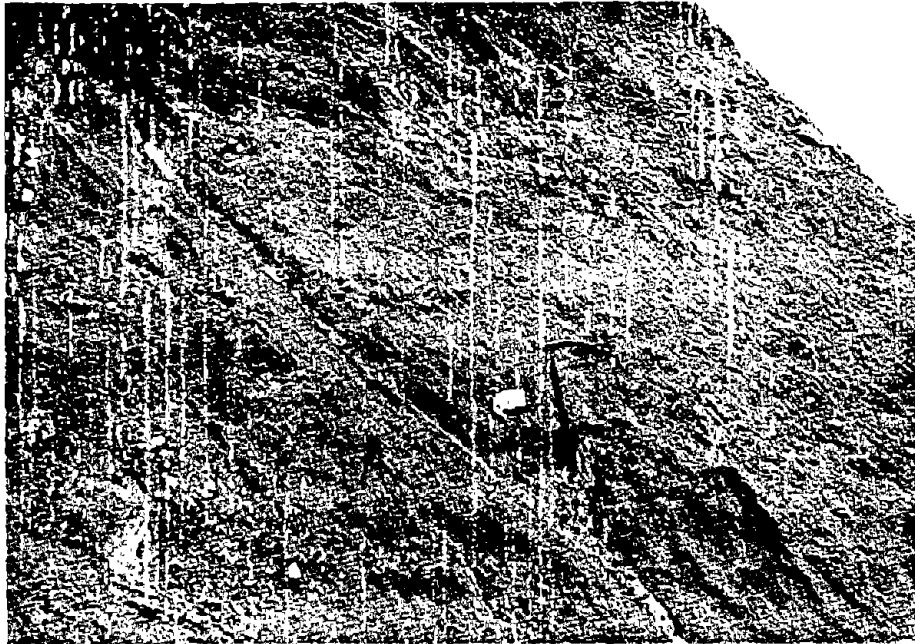
Photo 27. Location 22-3A, clay layer, 2 to 3 cm thick and continuous
for 8 m, rests on 1963 surface of sliding; clay overlies 0.5
to 1.0 m of cemented breccia dipping at 45-48° N; dips of
"bedding" and clay layers in slide debris above are flatter

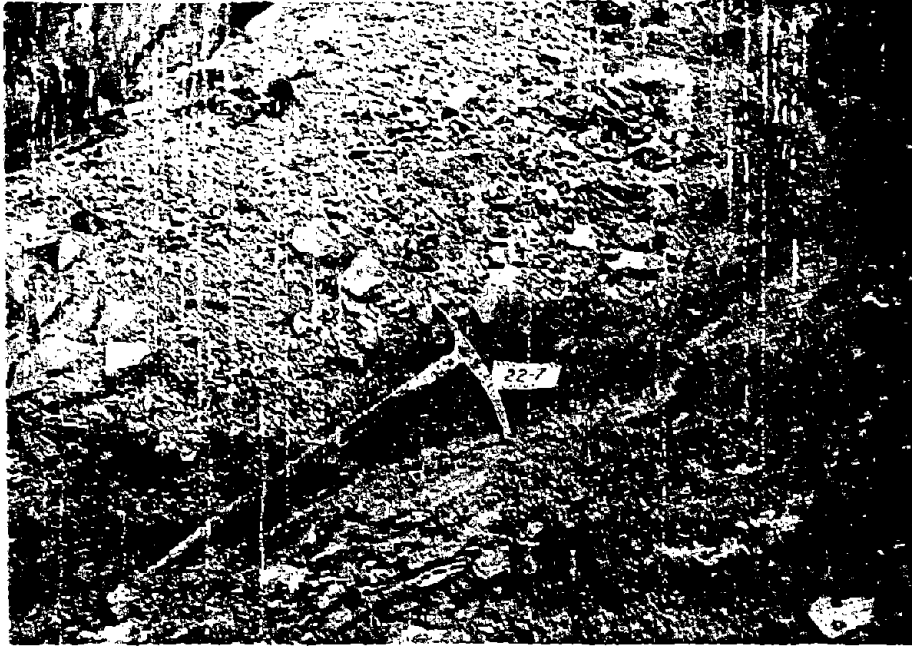
Photo 31. Location 22-7; clay layer 7 to 10 cm thick (max 20 cm) asso-
ciated with adjacent failure surfaces of 1963 slide is pro-
tected by small flexure (right-hand side has dip of 54° N)

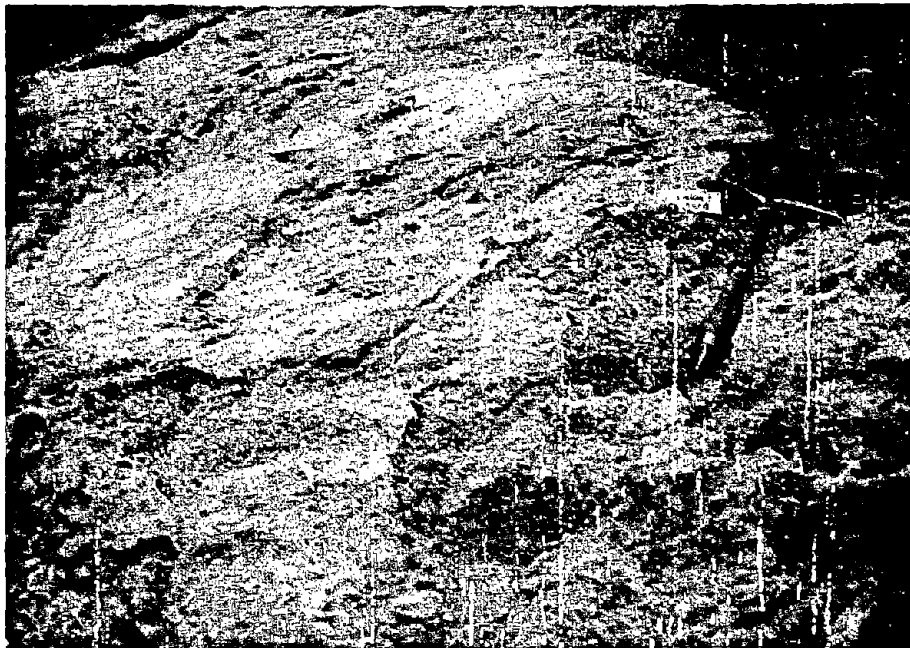
Photo 38. Location 12-1A, eastern surface of sliding; striations left
by 1963 slide appear on surface of cemented breccia of pos-
sible tectonic origin; surface:strike 20°, dip 46° W;
striations: 338° Az, plunge 30° N

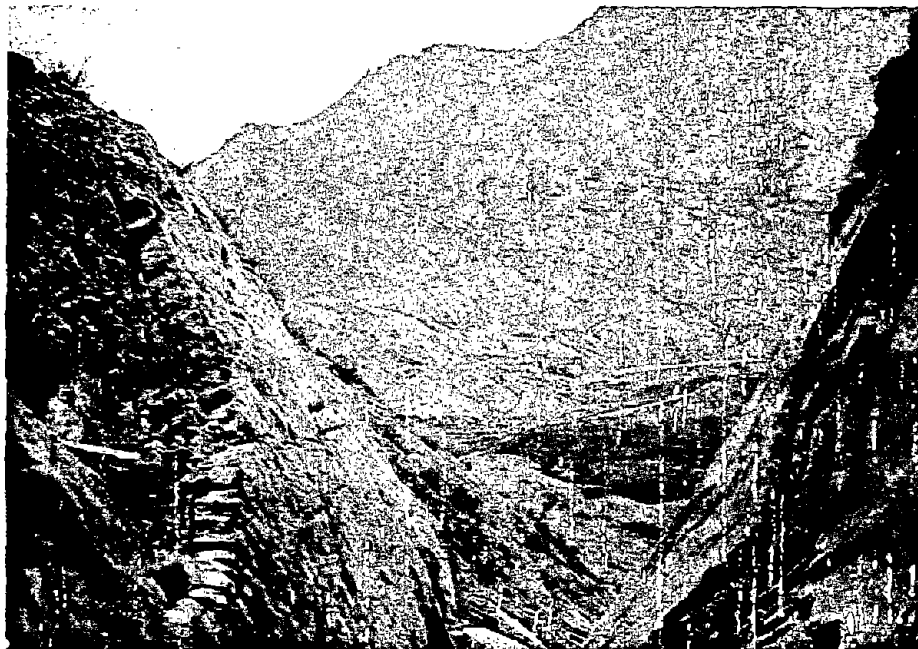
Photo 41.   Location 18-10, below western headscarp; striations caused by

1963 slide or post-1963 slides cut across bedding which has a
strike of 98° and dip of 30° N

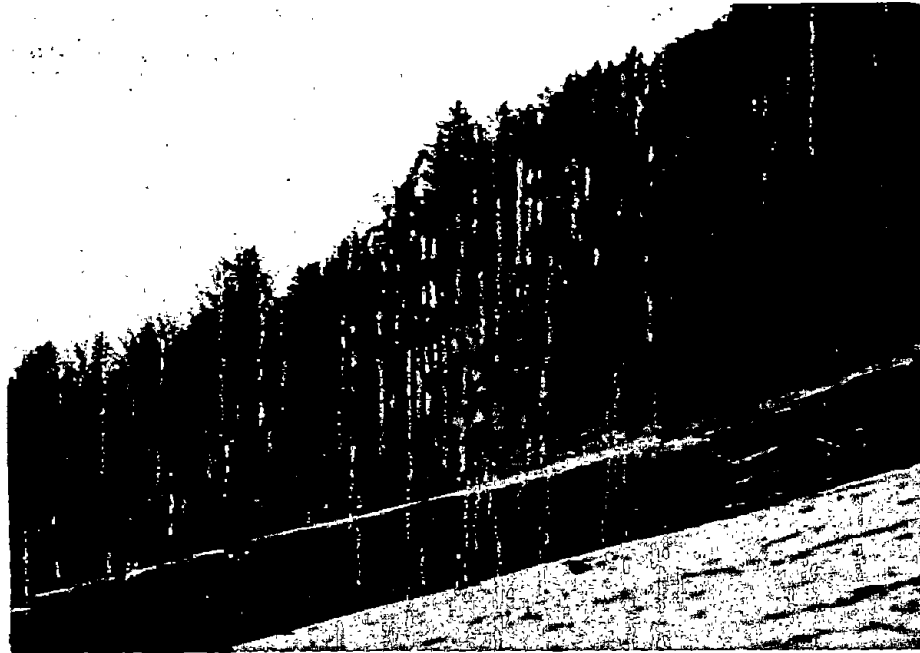
Photo 47. Location above 18-10; old vegetated headscarp is continuous
with new 1963 headscarp; two or more types of cemented
breccia have infilled old "bergschrund;" solution cavities in

better cemented (older?) breccia are visible on the right

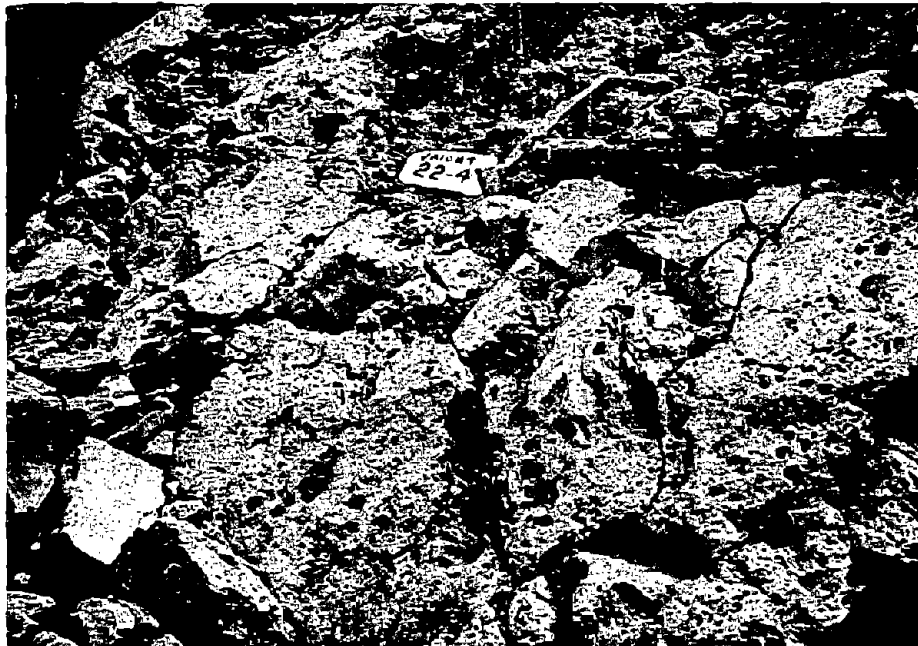
Photo 52. Location 22-4, eastern portion of slide just below surface of
sliding; solution cavities 0.5 to 1.0 cm diameter developed
along surface of sliding in cemented breccia of possible
tectonic origin
